Quality Assurance and Source Inspection

Contract #: 04-0120F4Cty: SF/ALA Rte: 80 PM: 13.2/13.9File #: 1.28**WELDING INSPECTION REPORT****Resident Engineer:** Casey, William**Address:** 333 Burma Road**City:** Oakland, CA 94607**Report No:** WIR-027733**Date Inspected:** 11-Jun-2012**Project Name:** SAS Superstructure**OSM Arrival Time:** 700**Prime Contractor:** American Bridge/Fluor Enterprises, a JV**OSM Departure Time:** 1730**Contractor:** American Bridge/Fluor Enterprises, a JV**Location:** Job Site**CWI Name:** As noted below.**CWI Present:** Yes No**Inspected CWI report:** Yes No N/A**Rod Oven in Use:** Yes No N/A**Electrode to specification:** Yes No N/A**Weld Procedures Followed:** Yes No N/A**Qualified Welders:** Yes No N/A**Verified Joint Fit-up:** Yes No N/A**Approved Drawings:** Yes No N/A**Approved WPS:** Yes No N/A**Delayed / Cancelled:** Yes No N/A**Bridge No:** 34-0006**Component:** Tower Component**Summary of Items Observed:**

Electroslag Weld Repairs

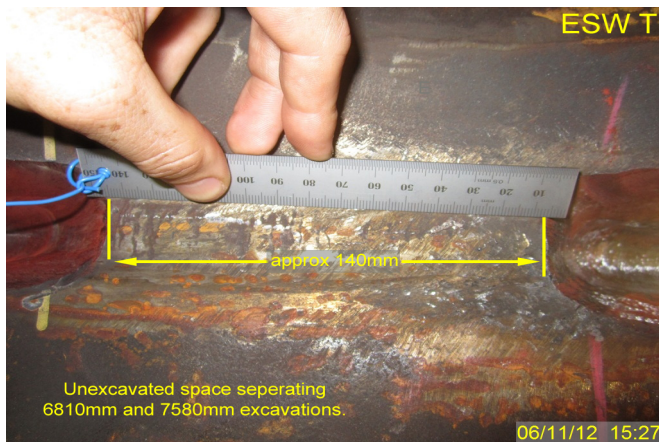
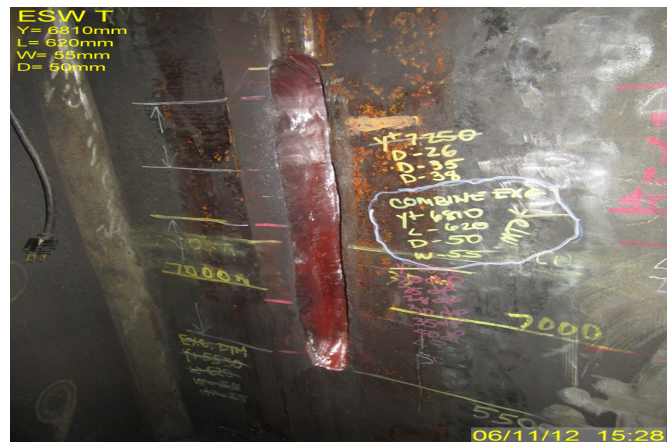
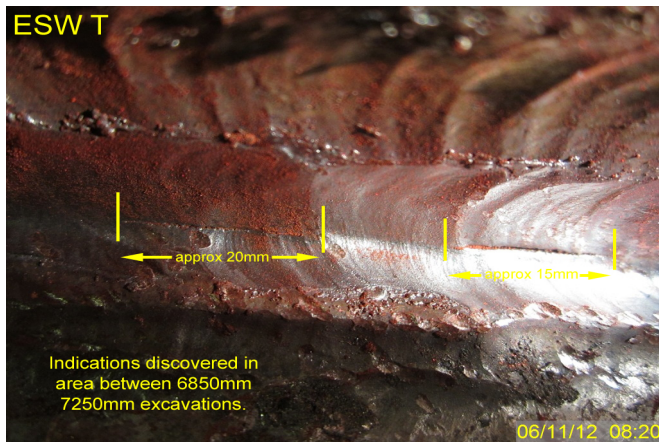
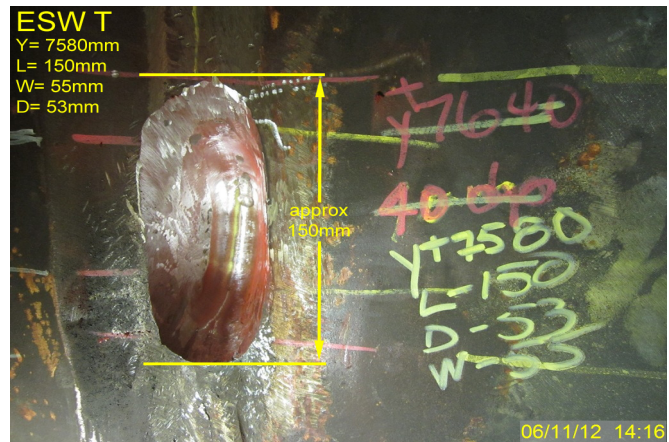
The UT discovered indications were found to be oriented in the longitudinal position. The indications were found to range from rejectable per AWS D1.5 Table 6.4 to within the recordable criteria to be subject to further Radiographic Testing (RT).

Throughout this excavation this QA observed and photographed multiple longitudinal linear indications ranging in sizes from approximately 20mm to 150mm.

Please see attached photographs for representative samples of indications observed.

The carbon arc gouging process, as well as machine grinding, were used to excavated approximately 2mm-5mm at a time. In between excavation passes both QA and QC performed Magnetic Particle Testing (MT) and photographed the removal of discovered indications.
